⑨ **BUREAU OF SHIPS GROUP**  
**TECHNICAL INSPECTION REPORT.**

⑥ **OPERATION CROSSROADS.**  
**U.S.S. RHIND (DD 404)**  
**TEST ABLE [U].** ⑧

**OPERATION CROSSROADS** **CONFIDENTIAL**  
Security Information

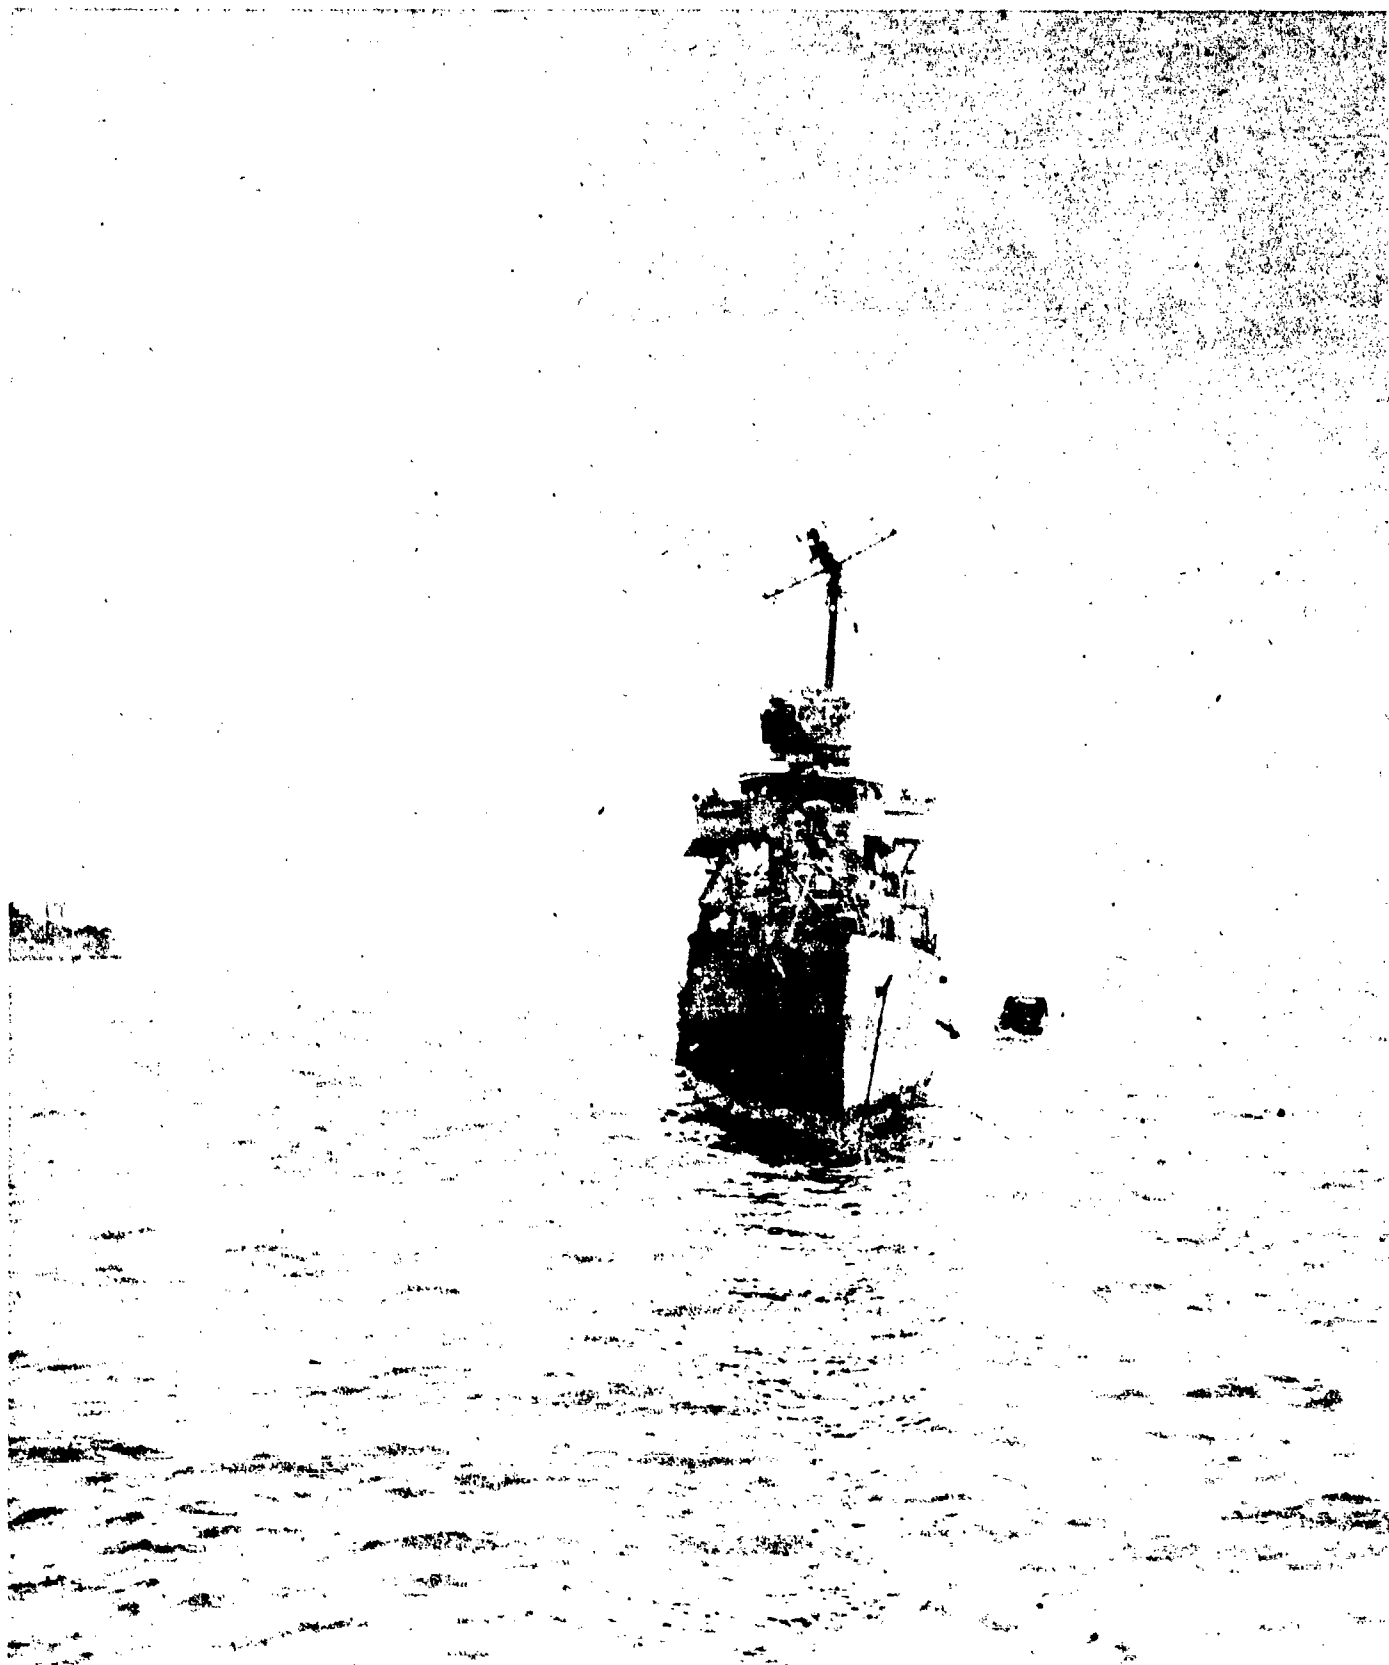
AA-CR-227-49-136. View from dead ahead after Test A.

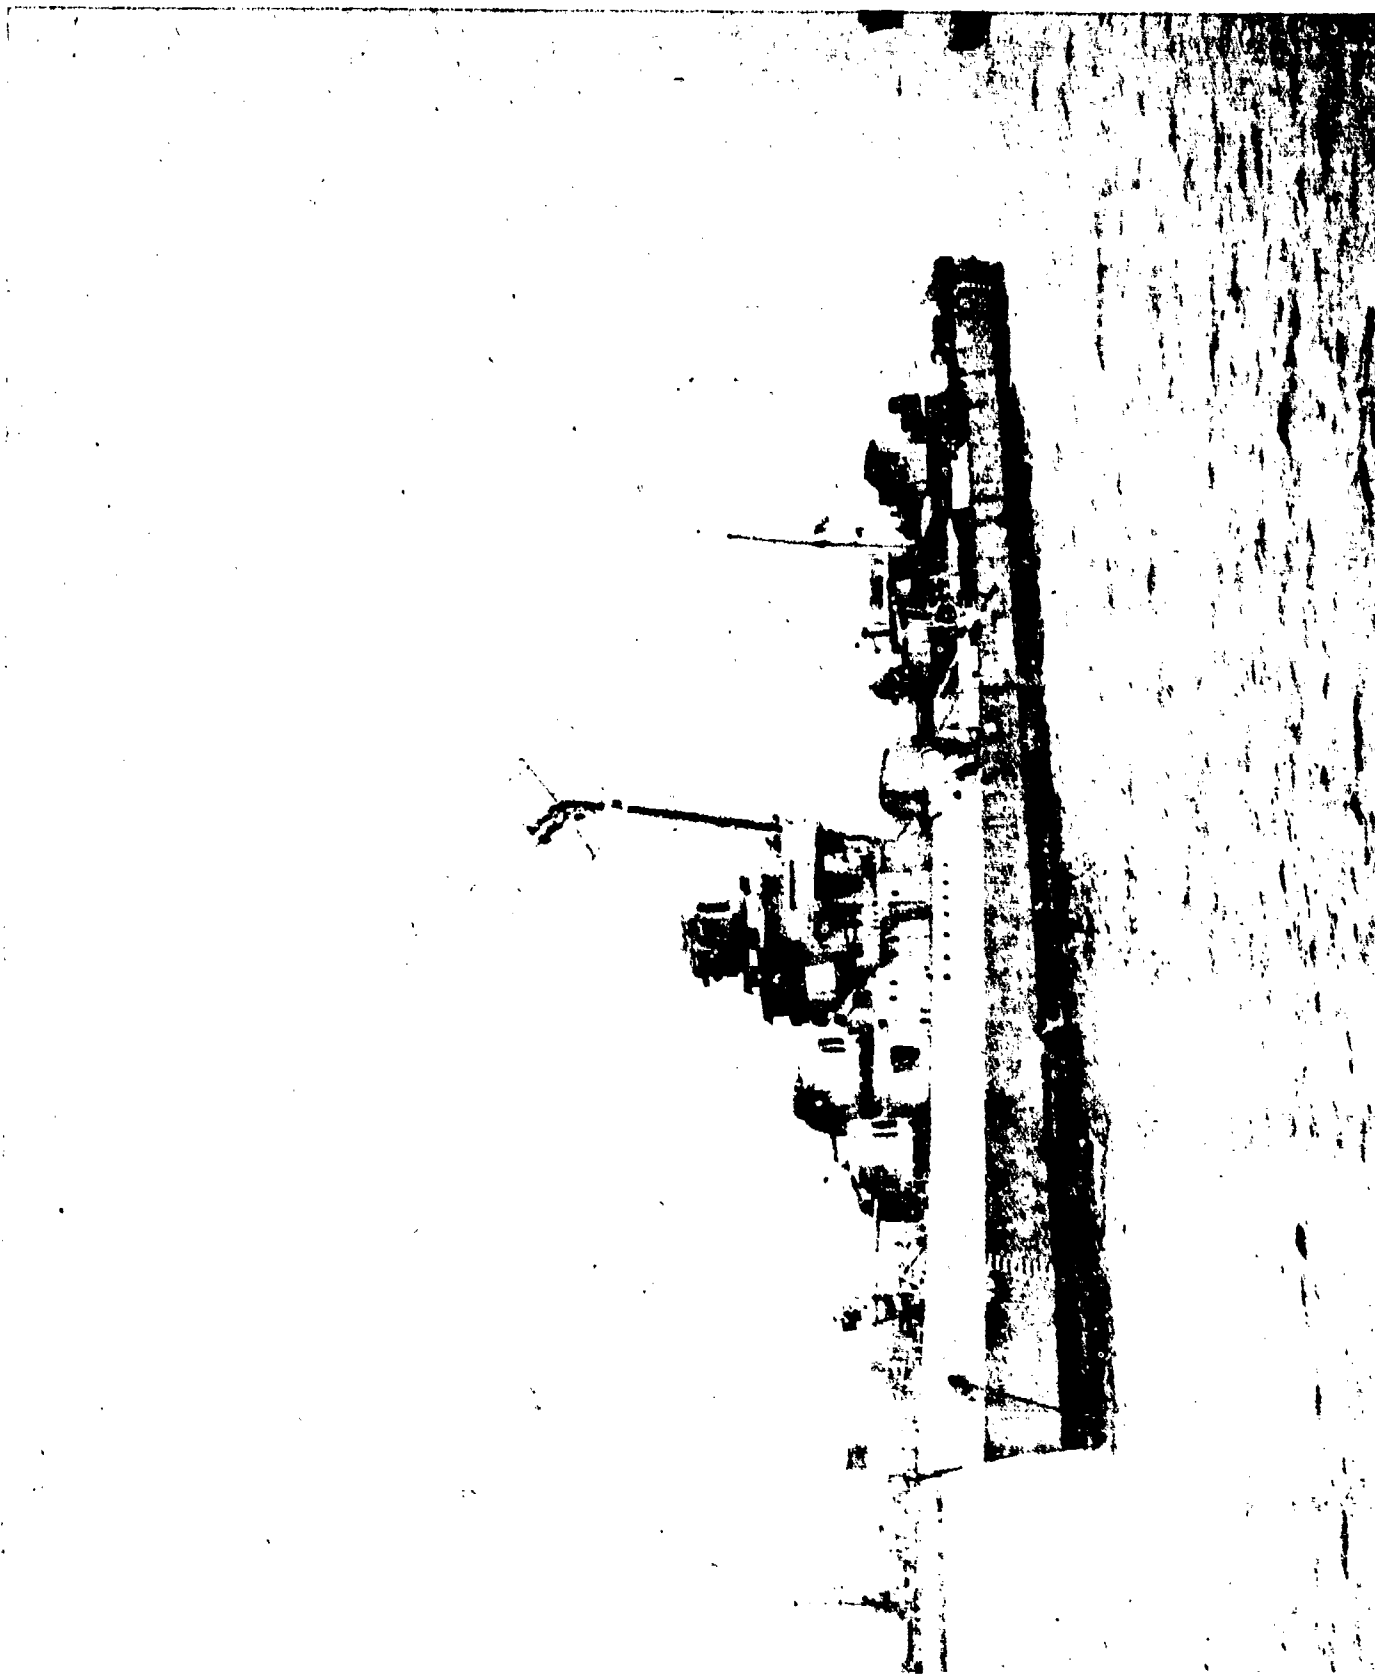
AA-CR-227-49-137. View from off port bow after Test A.

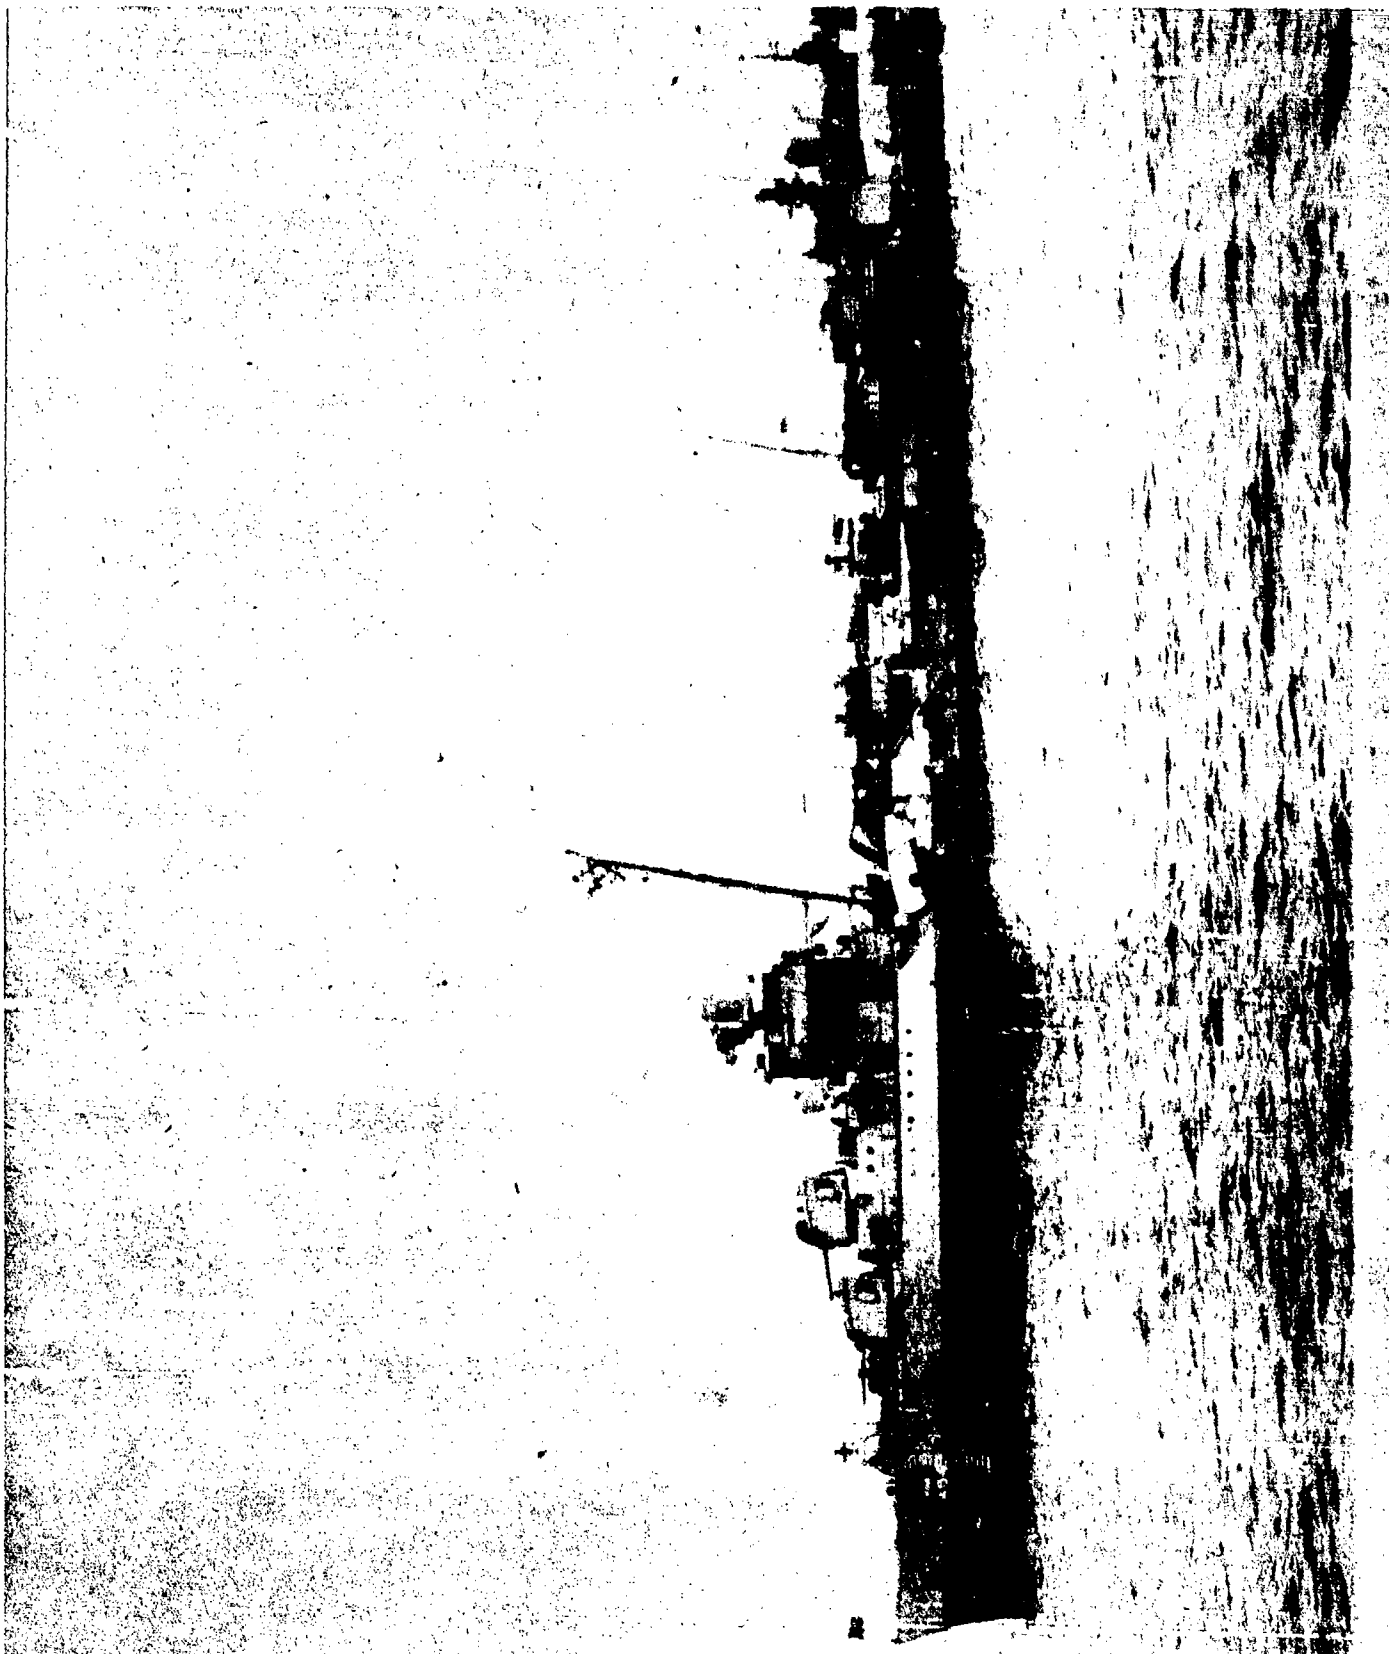
AA-CR-227-49-138. View from off port beam after Test A.

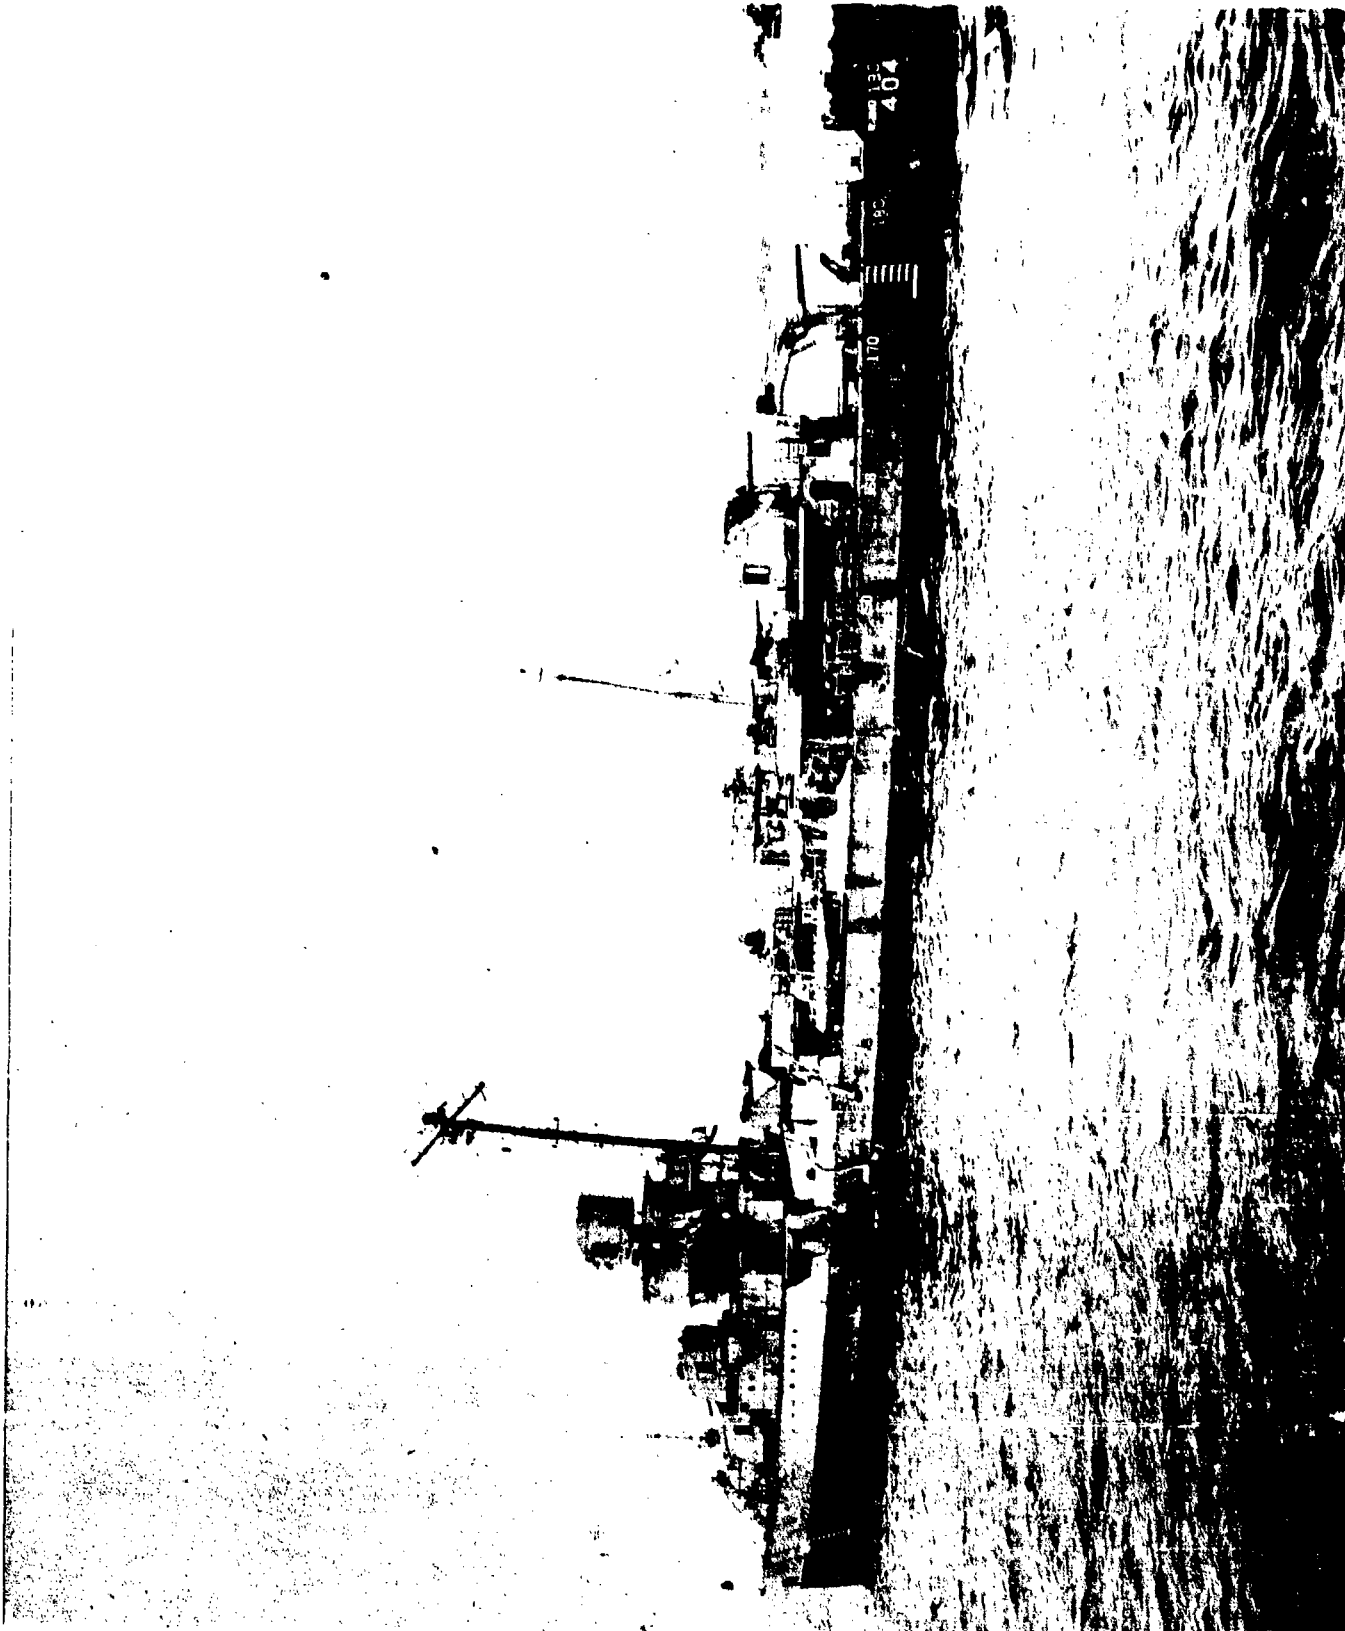
AA-CR-227-49-139. View from off port quarter after Test A.

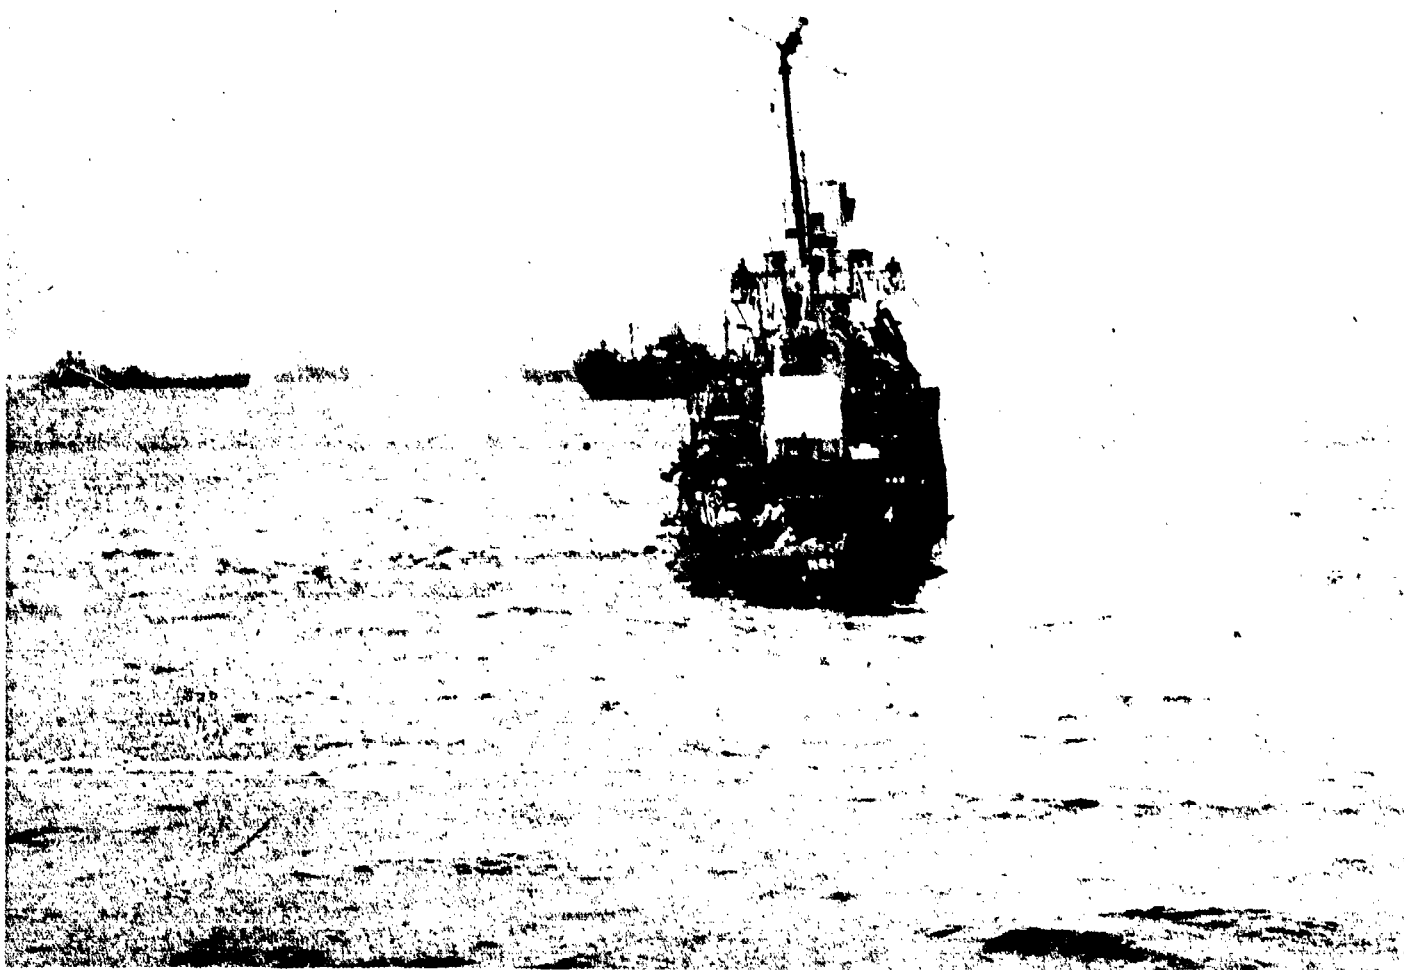
AA-CR-227-49-140. View from astern after Test A.

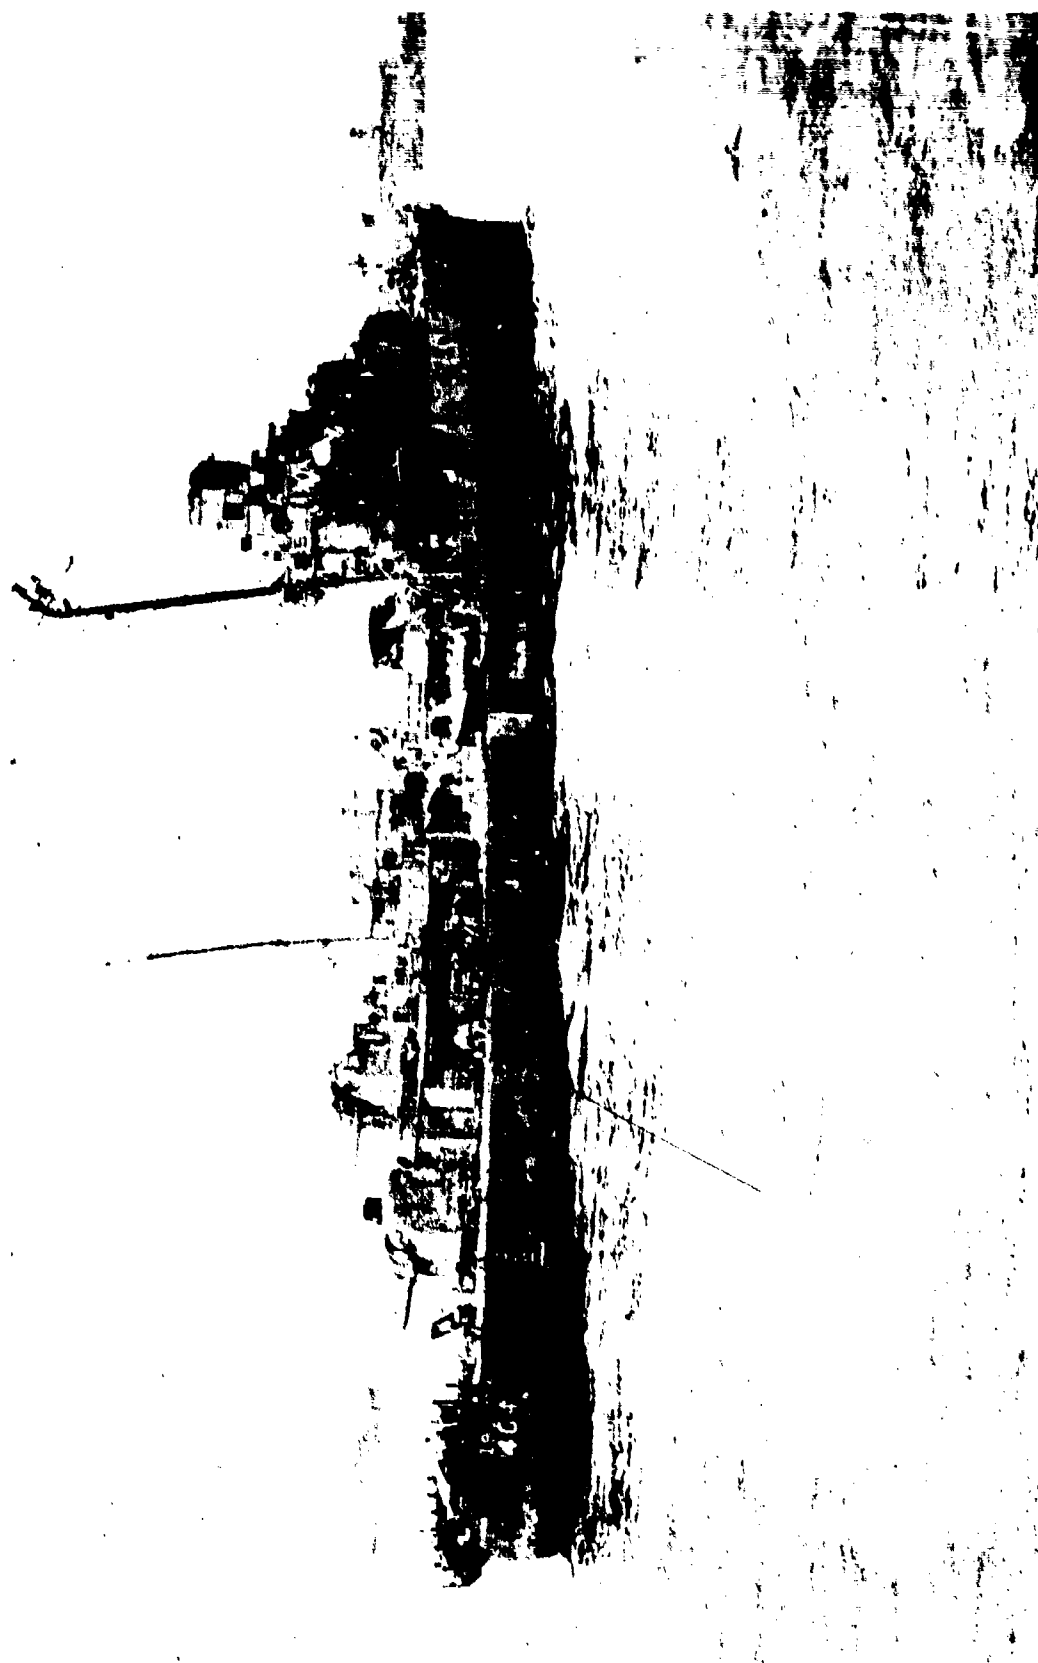
AA-CR-227-49-134. View from off starboard quarter after Test A.

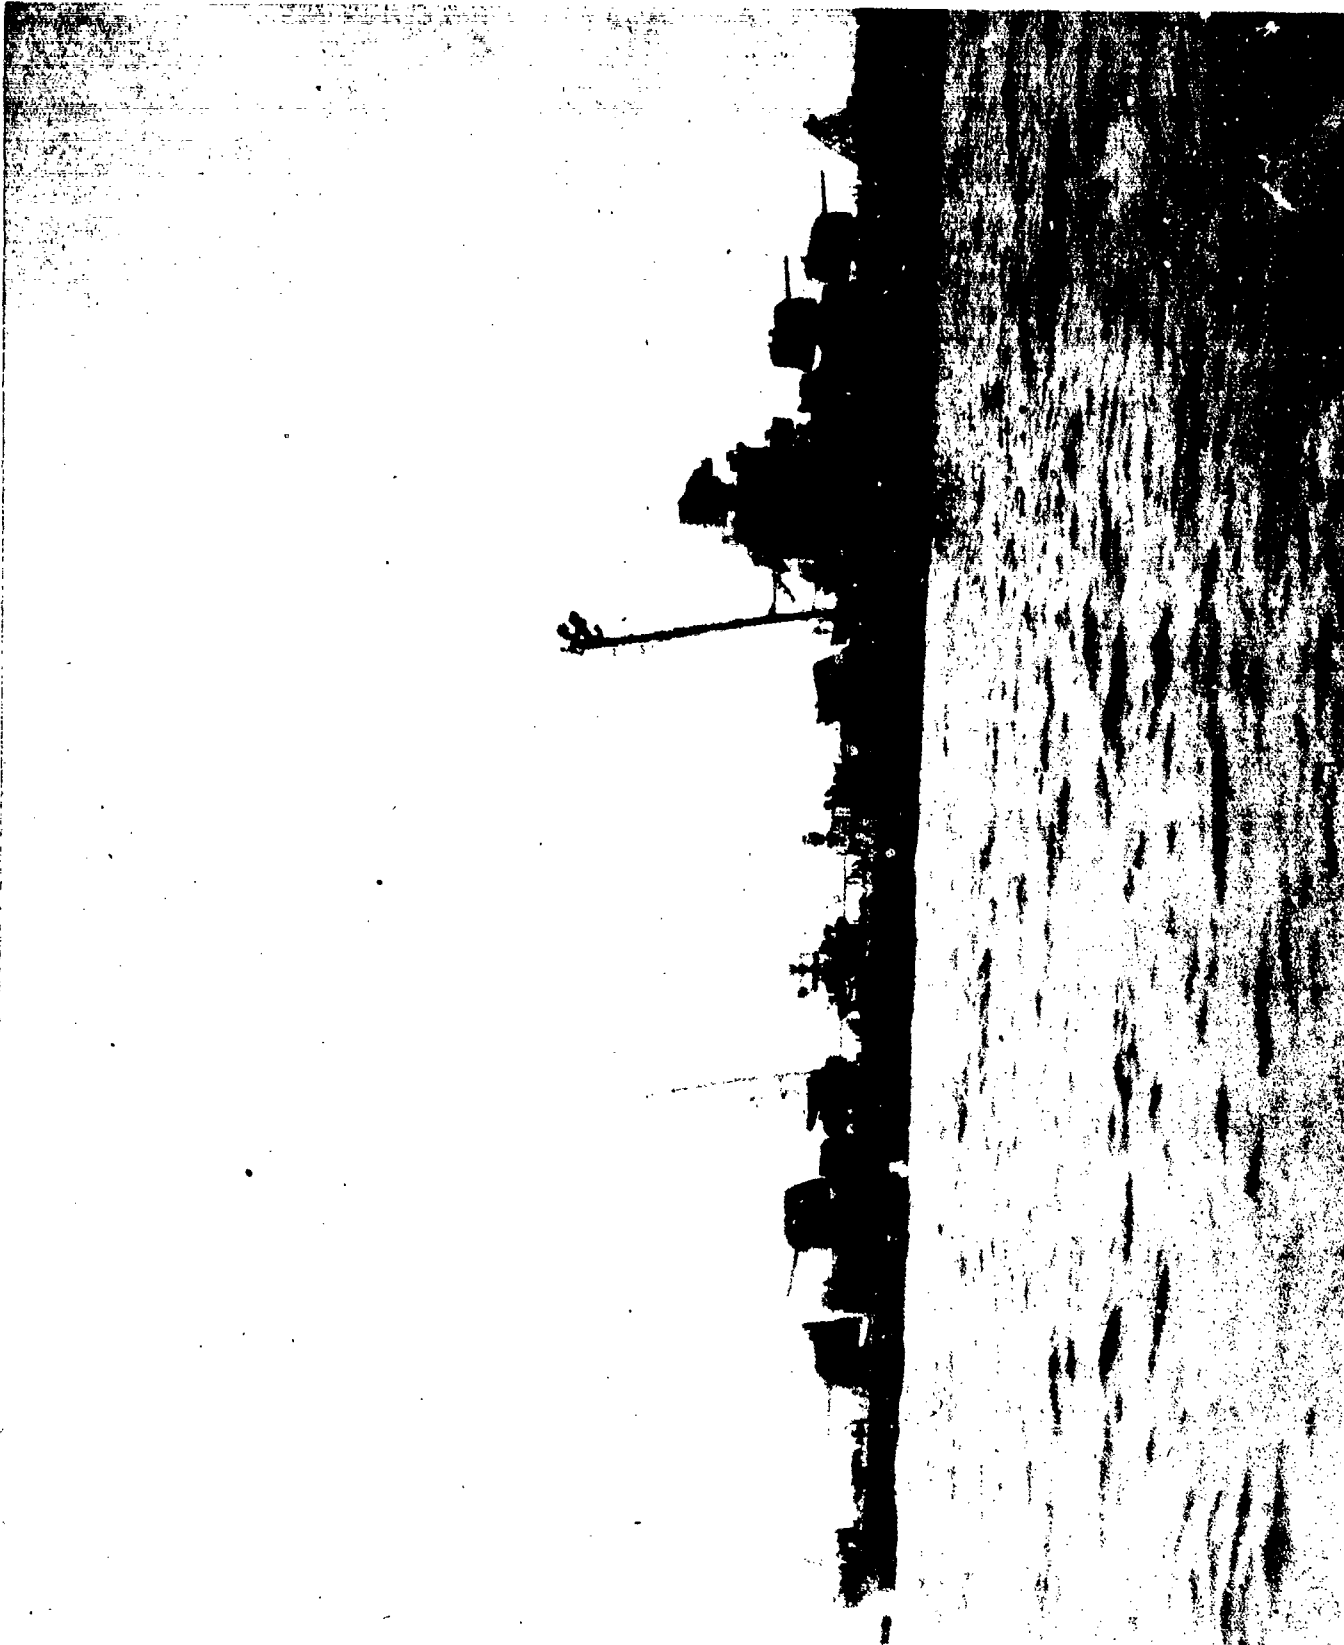
AA-CR-227-92-107. View from off starboard beam after Test A.

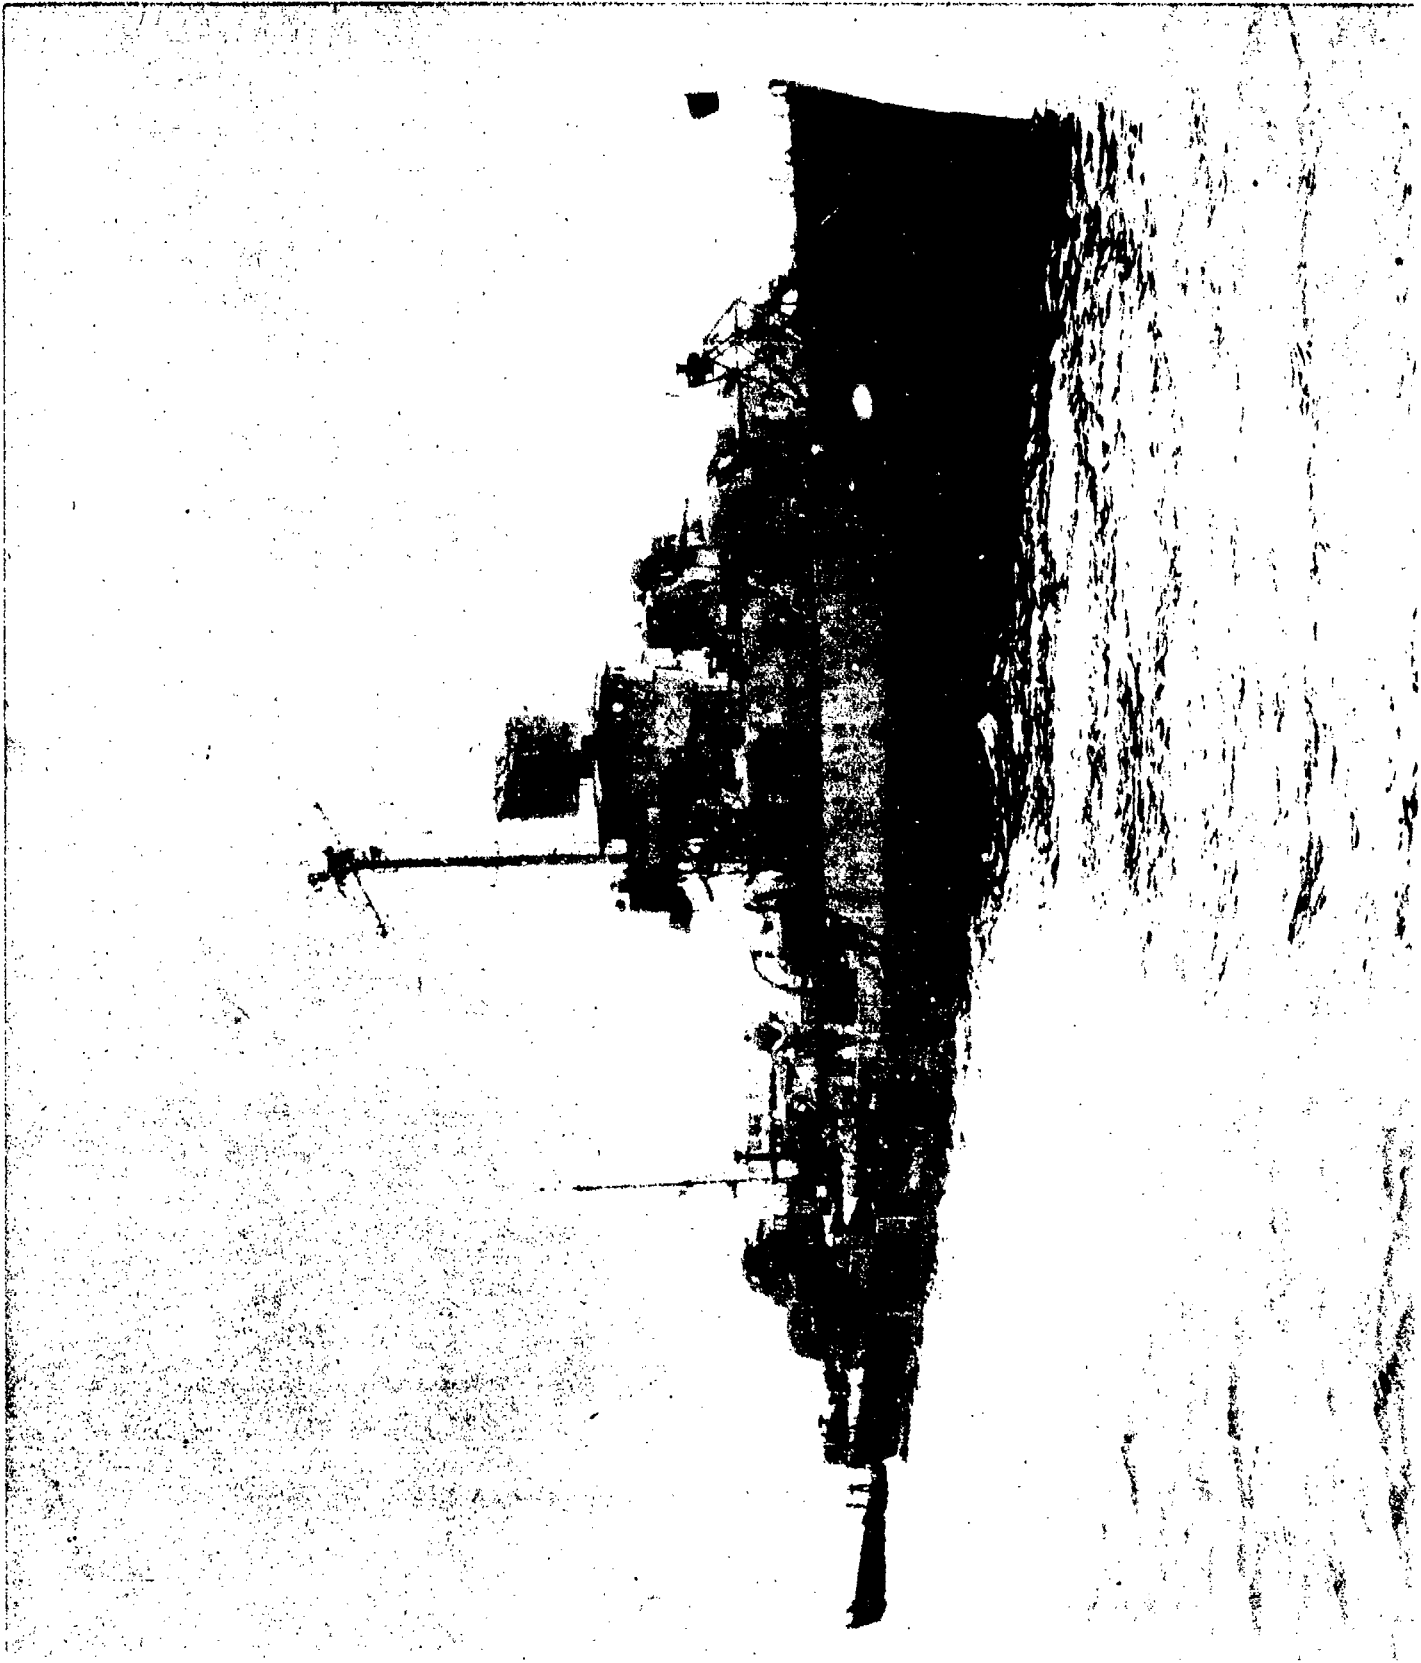
AA-CR-227-49-135. View from off starboard bow after Test A.

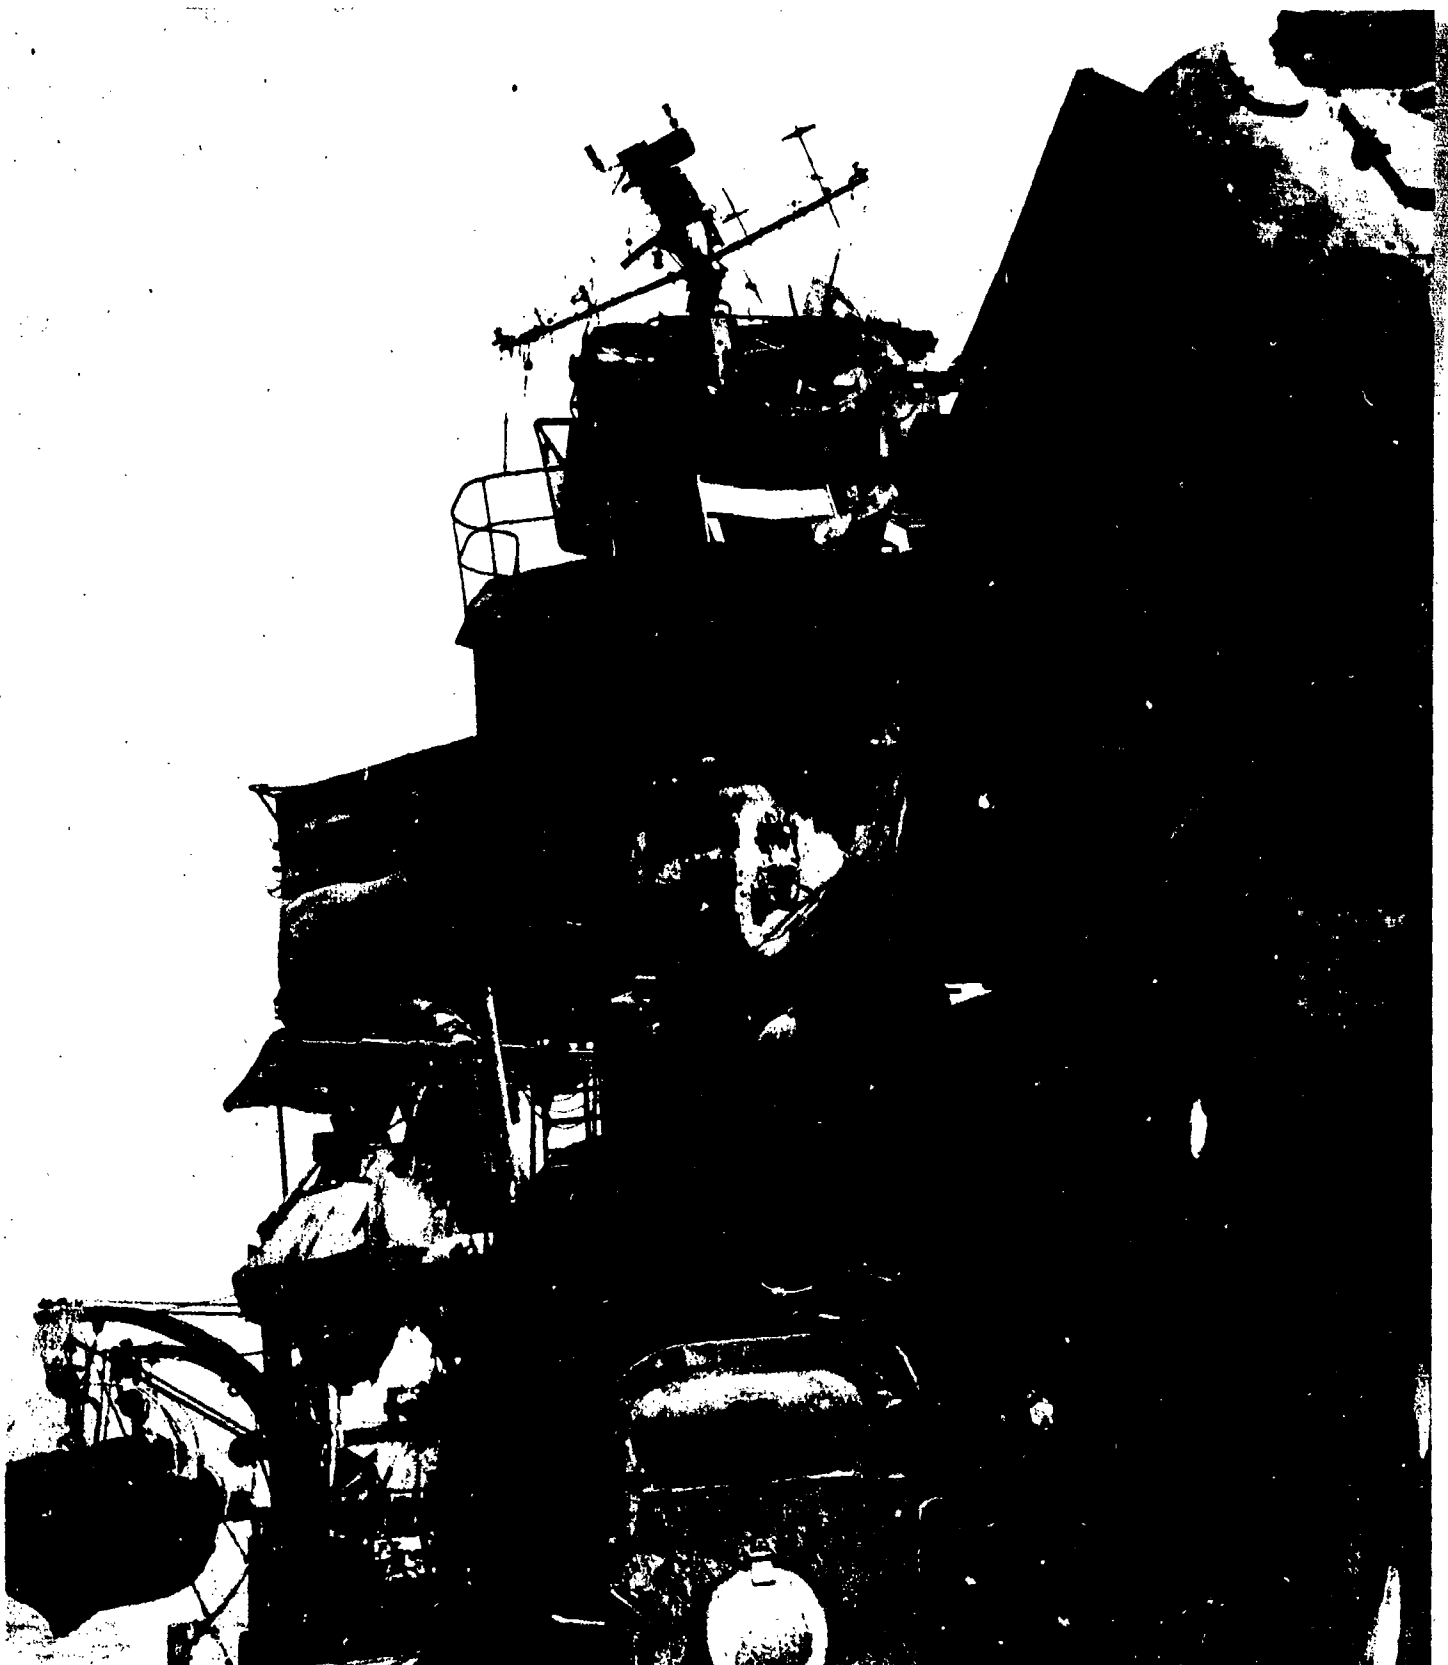
The forward bulkhead of the bridge is dished about two inches. Two brackets connecting the overhead girders and bulkhead stiffeners have failed. One panel of this bulkhead is opened slightly in way of a riveted seam where the rivets failed. (Photographs 2005-5, page 68, 2010-11, page 69, and 1712-1, page 70.)

AA-CR-58-2005-5. General view of damage looking aft along the starboard forecastle deck.

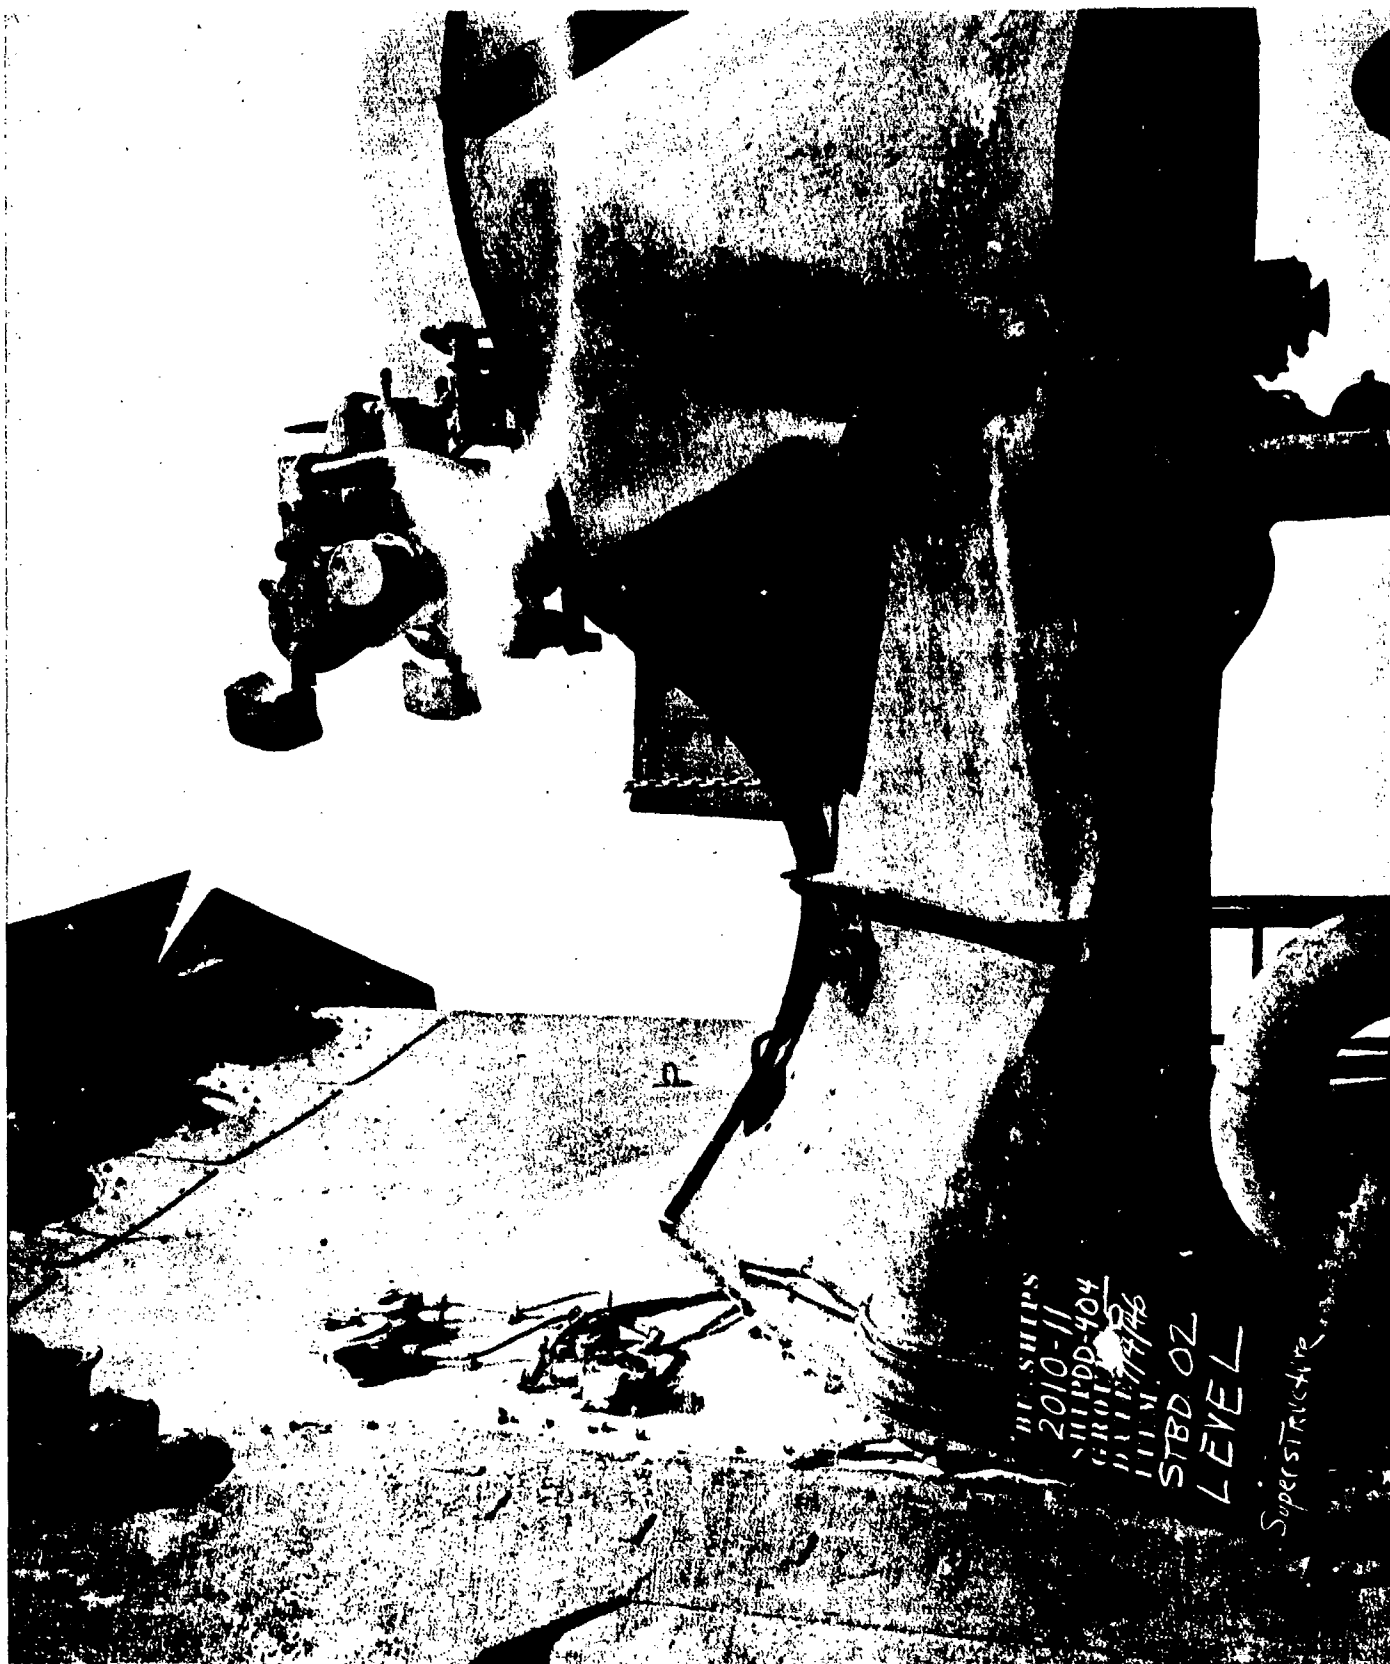
AA-CR-58-2010-11. View looking athwartship in front of bridge, 02 level. Showing damage director shield and scorched paint on house.

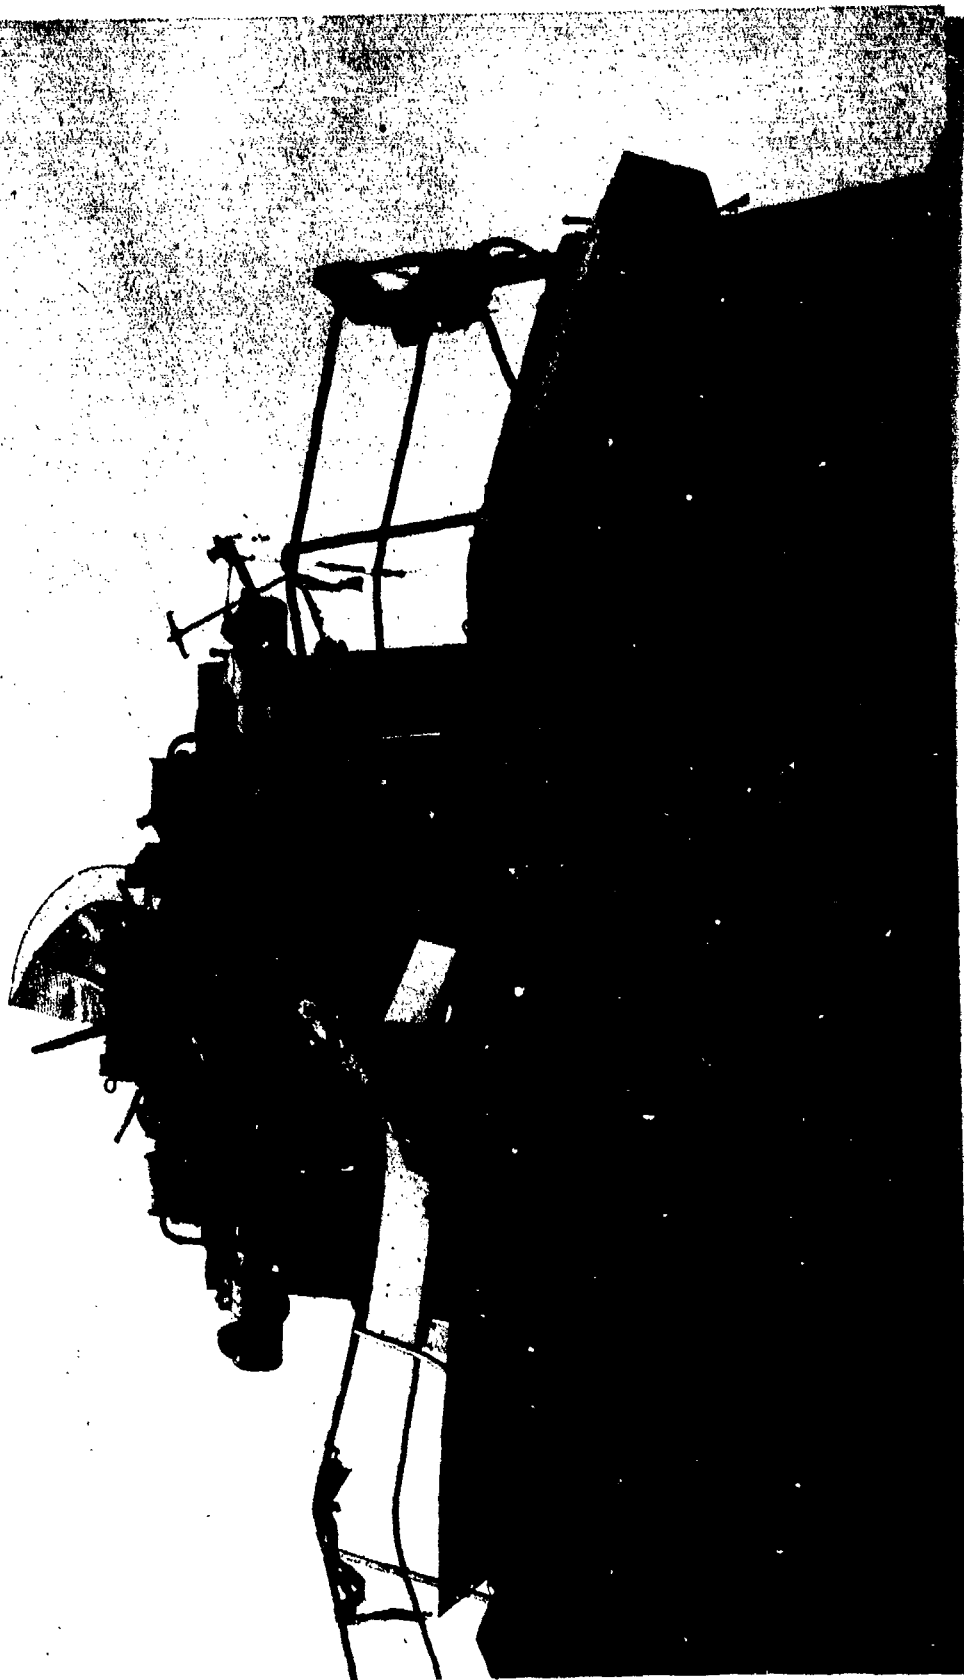
AA-CR-92-1772-1. View looking aft showing damage in navigating bridge area.
